Test Summary

Resonant Fatigue Testing
4 1/2" OD, 11.60 ppf, P-110 GB HB
7" OD, 23.00 ppf, P-110 GB HB

September 14, 2009

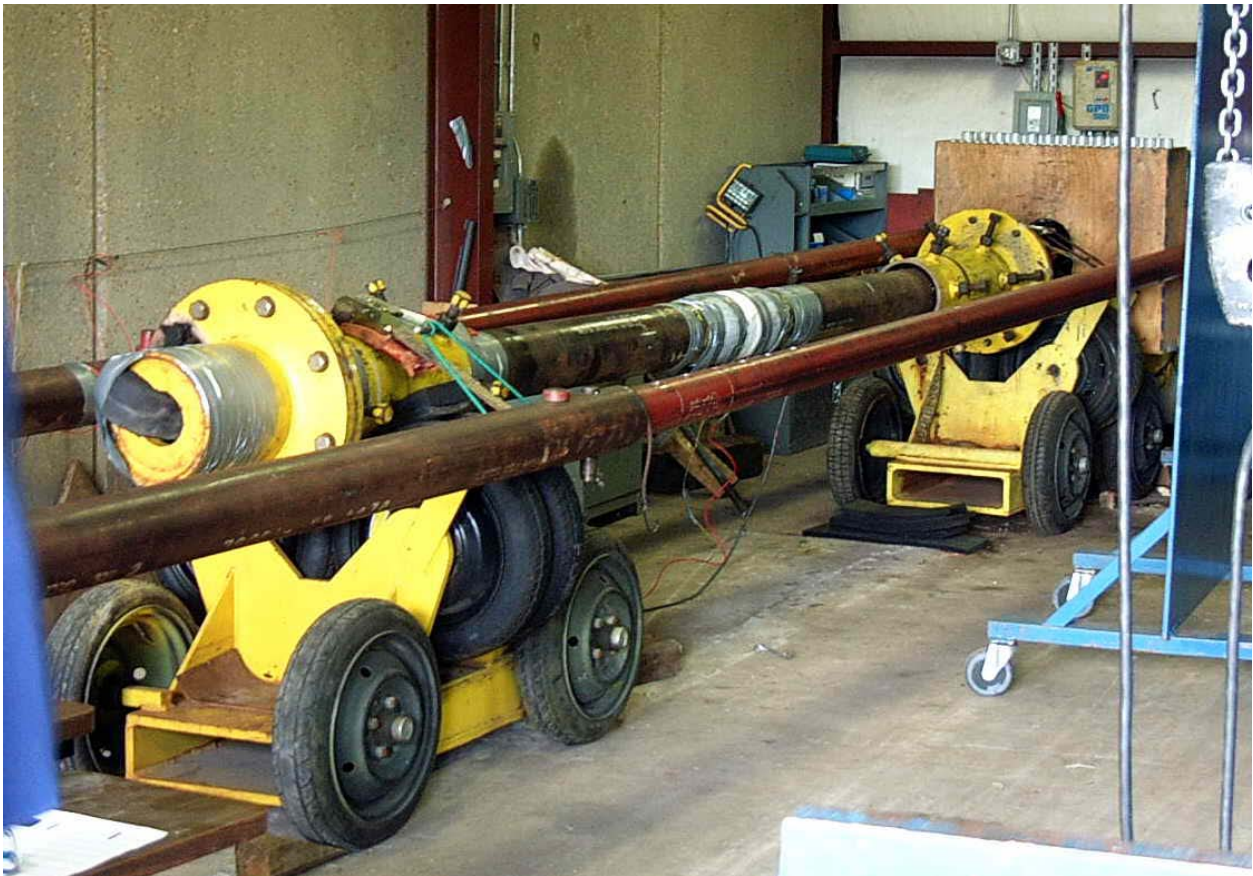
Resonant fatigue cycling was designed to simulate a 3°/100 ft. bend in the casing and was performed with 200 psi internal hydrostatic test pressure. After the initial number of cycles was achieved, the sample was hydro-tested to 2,000 psi for 1 hour. Pressure testing was performed again at the same pressure and hold time after the second round of fatigue testing.

Resonant Fatigue Test Equipment

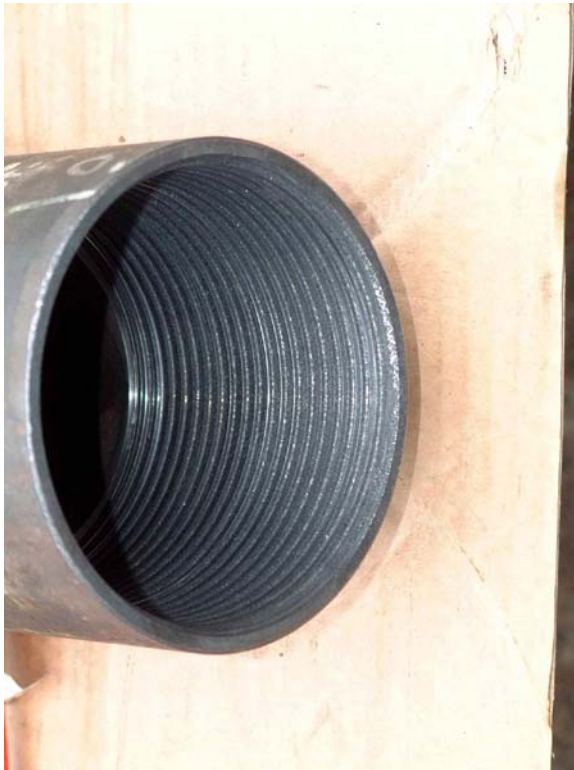
The GB HB Connections on both casing sizes demonstrated good repeatability during make/break testing. The threads were in excellent condition even on the final breakout after fatigue and pressure testing. All parts were re-used "as-is" after each breakout without any field dressing (because observed threadform disturbance was minor). Successful positive test results are more remarkable given the fact

that all threads were re-used without field dressing. Based on observations at the time of testing, it is unlikely that the parts would have required dressing prior to re-use in the field.

Coupling Threads after Breakout

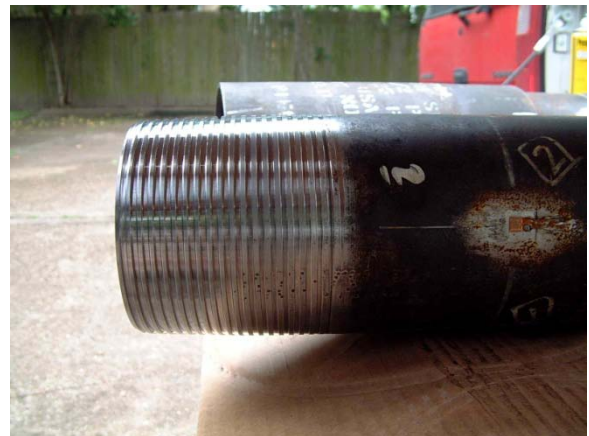
Pin Threads after Breakout
